KINCAID SERVICES RESIDENTIAL REPORT COPY

1234 Old Schuylkill Rd
Spring City, PA 19475

Preston Kincaid
JANUARY 29, 2022

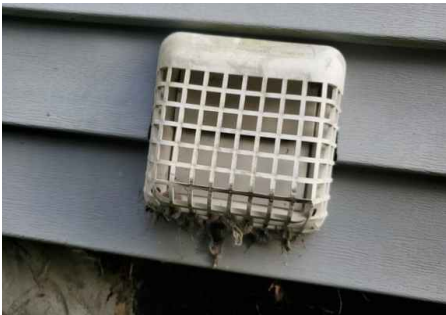
**Dryer Exterior Vent Cover: Exterior Dryer Vent Cover**

The dryer vent was observed to be satisfactory with some lint build-up.

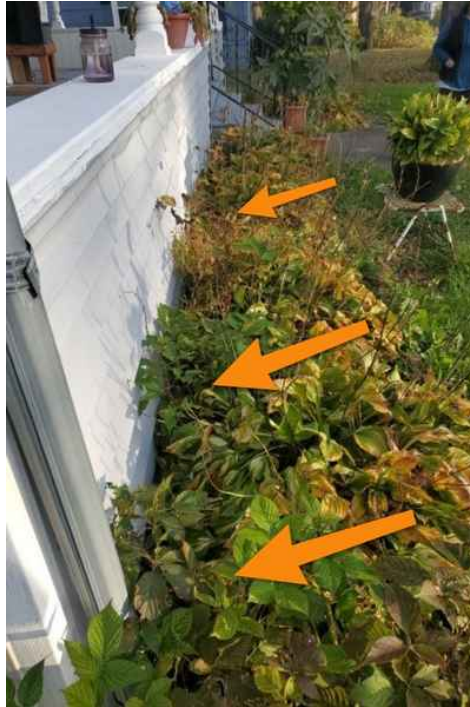
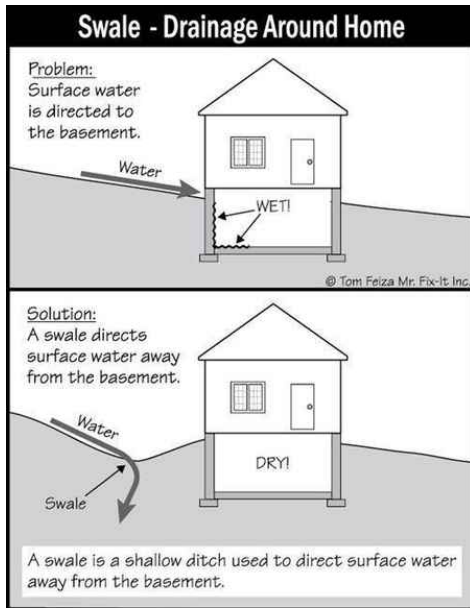
The home was built on a sloped embankment. Some areas of the grade around the perimeter of the foundation were observed to be inadequately directing water away from the home and in one or more areas is directing water at the home's foundation, and as a result water intrusion was present in the basement.

Recommend improvements be made by grading the soil around the home with a compactible soil to adequately direct water away from the foundation perimeter. The general goal is to have 6" of grade fall within the first ten feet of the foundation perimeter. A swale should be considered when consulting with a landscape contractor.

Contact a qualified landscaping contractor

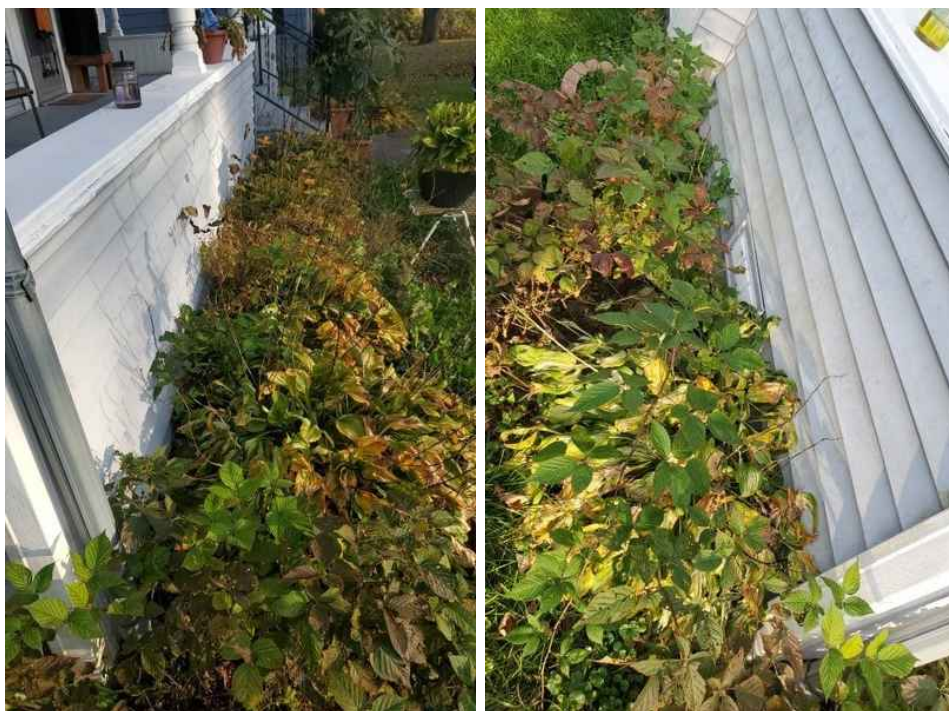
2.2.1 Vegetation

VEGETATION OBSERVED CLOSE TO HOME

Vegetation was observed close to or touching the home. Vegetation (trees, bushes and shrubs) against the home can cause moisture retention against the siding and/or foundation which can cause the exterior siding of the home to discolor, deteriorate or grow moss. Moisture retention can also cause the foundation to deteriorate in some cases. Furthermore, moisture can attract insects, including termites.

Recommend trimming the vegetation back so there is a minimum of 2 feet distance from home, although 4-5 feet is ideal.

Contact a qualified landscaping contractor

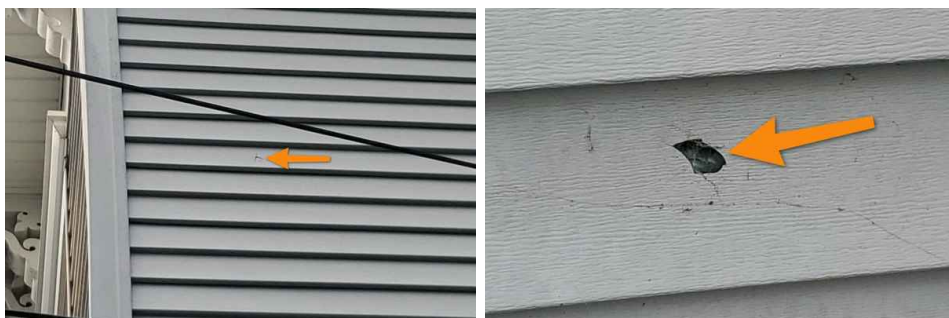
2.4.1 Cladding, Flashing & Trim

GAPS, CRACKS, HOLES OR OPENINGS

Gaps, Cracks, Holes or Openings were observed in the siding and/or exterior cladding. These areas represent a moisture intrusion risk and can lead to water damage of the interior walls or structure. Recommend repair by a qualified handyman or siding contractor.

Contact a qualified handyman.

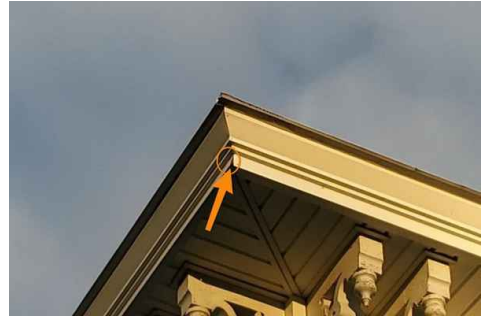
2.8.2 Eaves, Soffits & Fascia

SOFFIT OUT OF CHANNEL

Recommendation

Contact a qualified siding specialist.

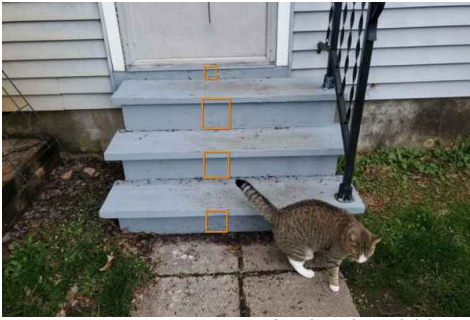
Stir risers are over 8.5" high. Should be between 7 and 7-3/8"

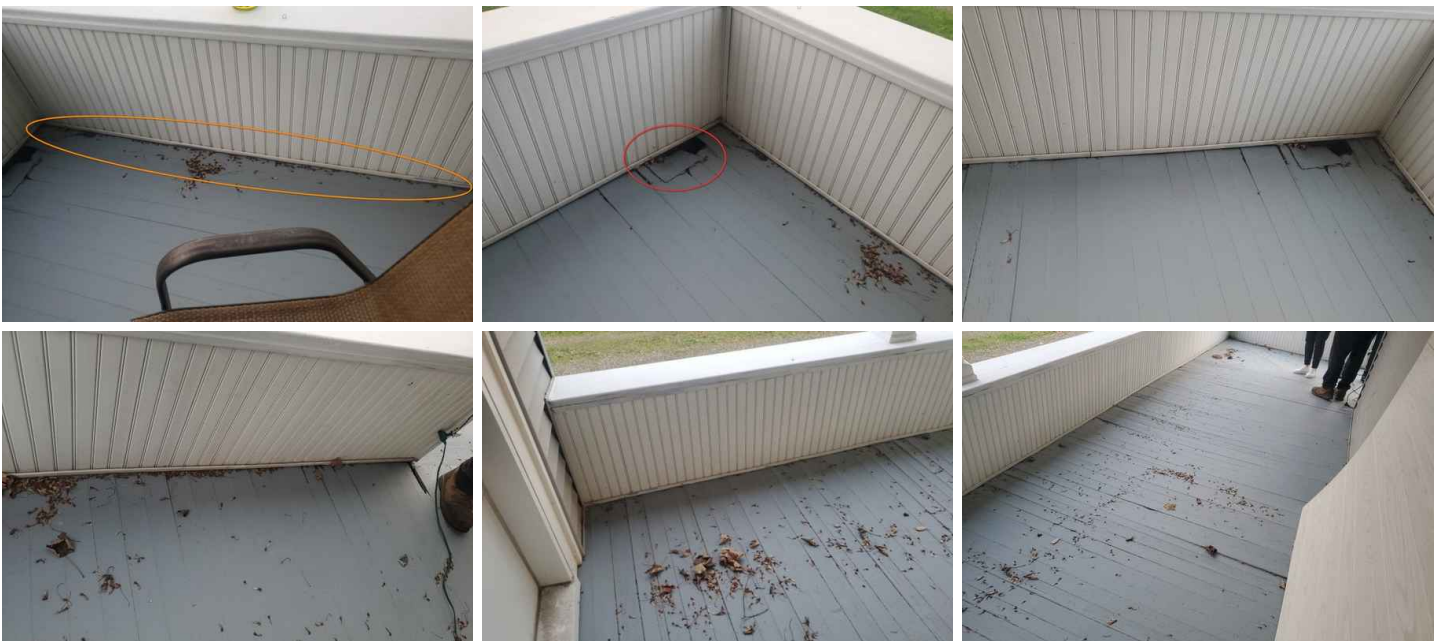
DECK AREAS ROTTED AND UNSAFE

The front perimeter of the deck was observed to have decking that is soft, rotted and inadequately supported. It is the opinion of your inspector that the lack of "scuppers" or drains to allow water drainage has allowed moisture to rot and/or deteriorate the supporting members and decking at the front edge perimeter. There are sections of rotted and/or missing decking that can allow someone to step into and fall. This is a safety hazard. Recommend repair by a qualified deck contractor.

Example of a deck with scuppers for drainage.

Contact a qualified deck contractor.

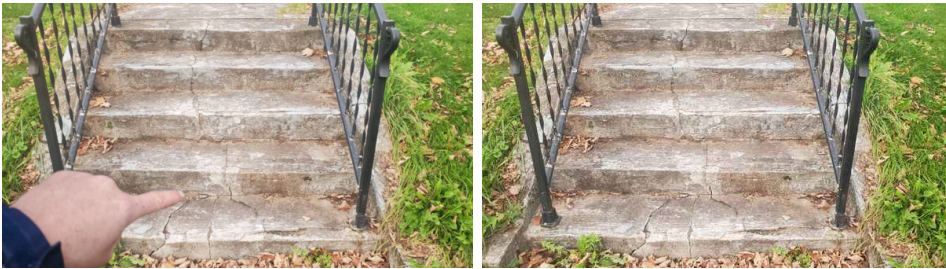
The concrete steps nearest the sidewalk were observed to be significantly cracked, and in generally poor condition. Recommend further evaluation and repair as needed by a qualified concrete or masonry contractor.

Contact a qualified concrete contractor.

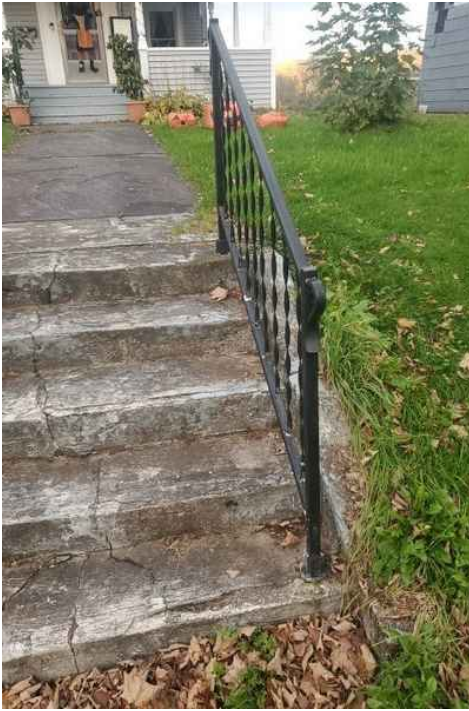
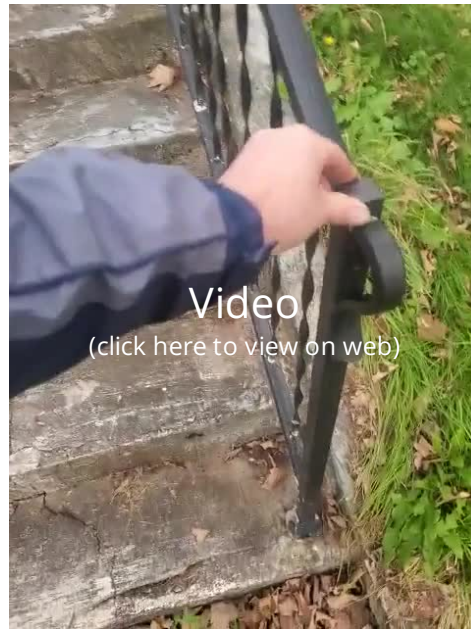
2.11.1 Guardrails, Stair Rails, & Handrails

GUARD RAIL - LOOSE (SAFETY HAZARD)

Contact a qualified deck contractor.

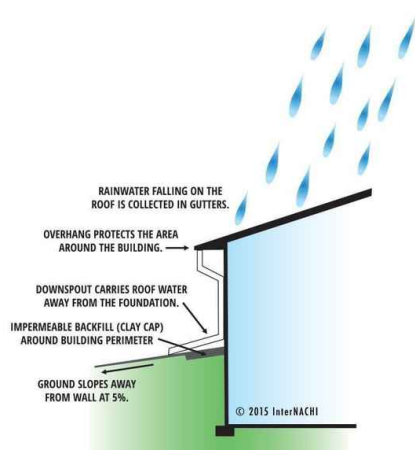
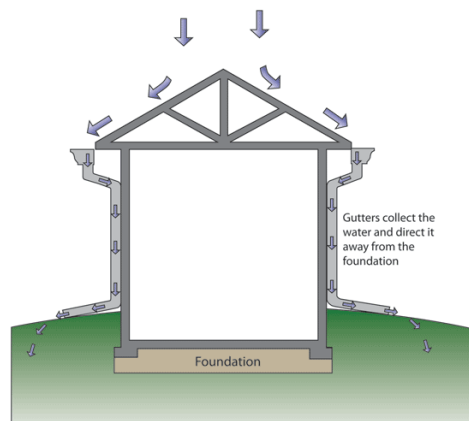
2.12.1 Roof Drainage System (Gutters / Downspouts)

OVERALL - INADEQUATE ROOF DRAINAGE SYSTEMS

Roof drainage systems are one of the most important components to your home.

- Recommend adding proper gutters, flashing, kick-out flashing and downspout drains that directs water at least 6' away from home.

Contact a qualified gutter contractor

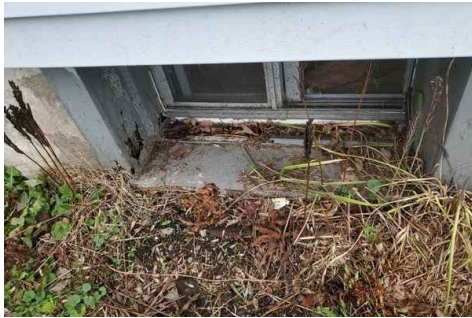
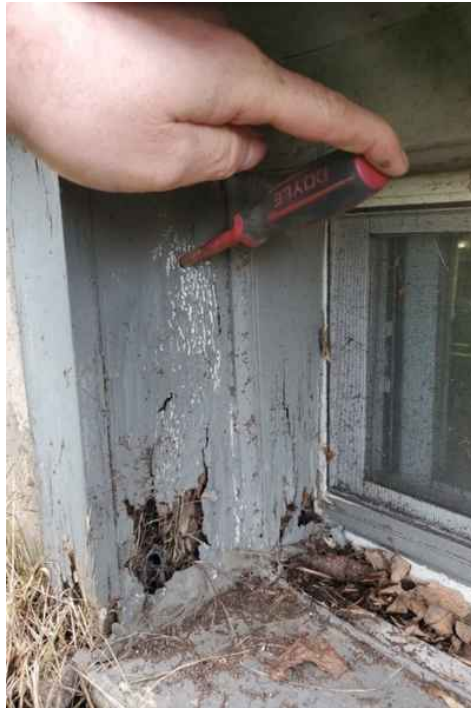
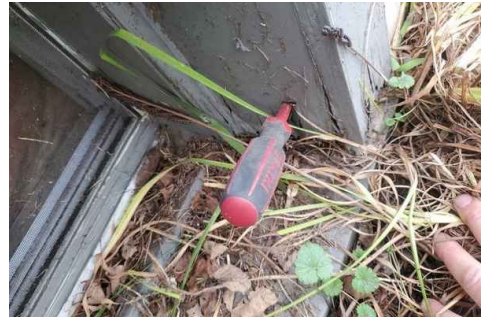
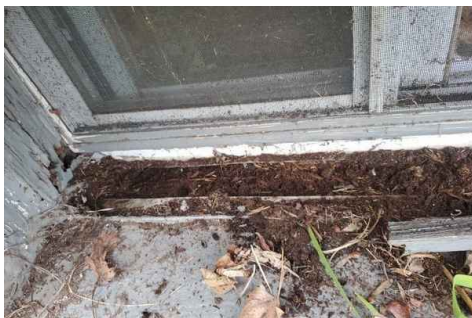
An example of a window well cover installed to prevent water intrusion.

Contact a qualified handyman.

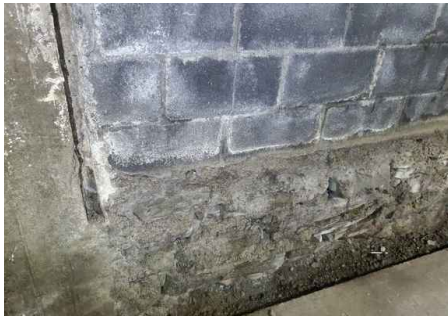
Original stacked stone with masonry block retrofit repair.

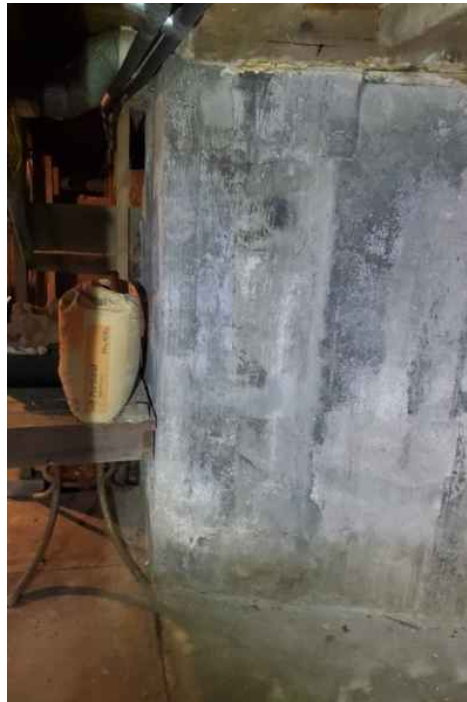
Area of foundation where poured concrete was implemented to replace original stacked stone.

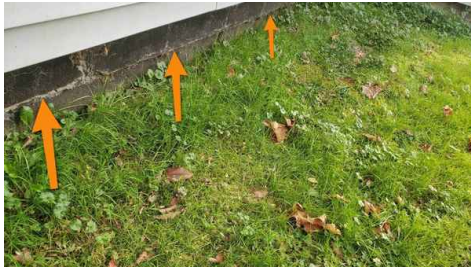
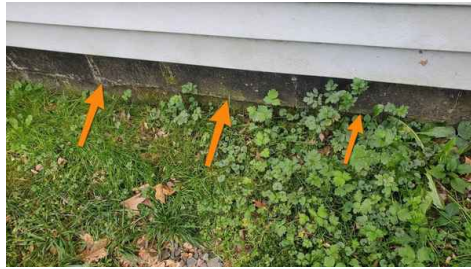
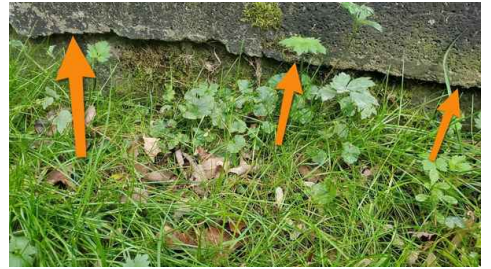
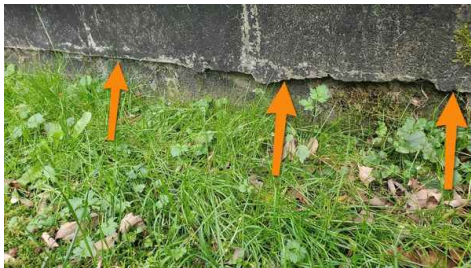
A swale should be considered when consulting with a qualified landscape contractor.

Contact a foundation contractor.

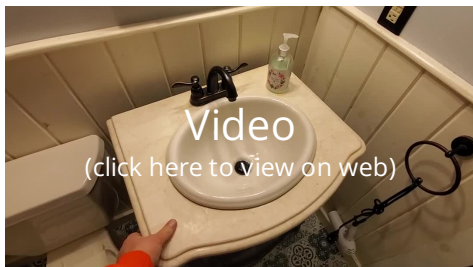
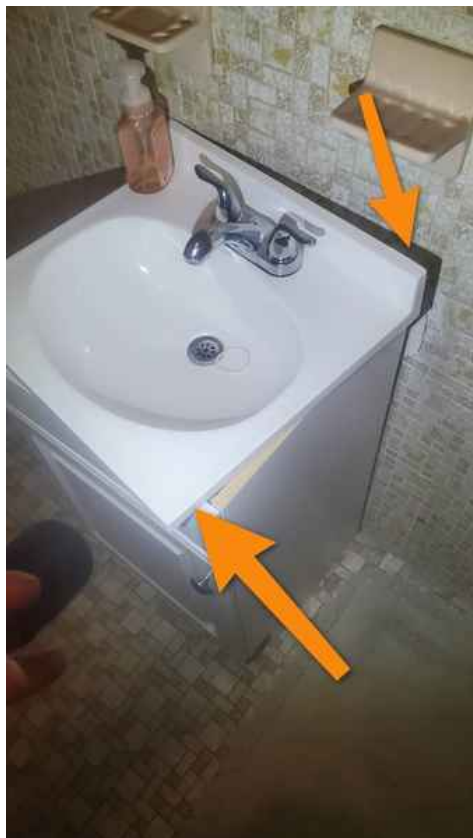
Vanity or countertop was observed not to be secured properly. Recommend repair by a qualified handyman.

Contact a qualified handyman.

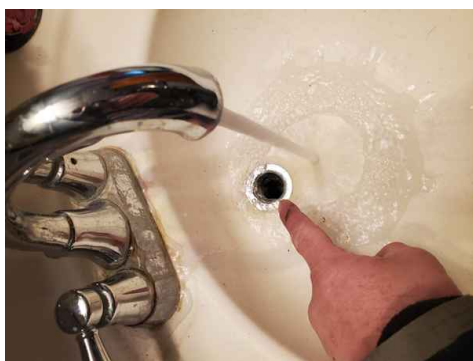
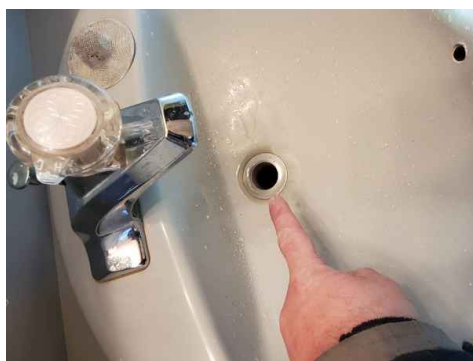
4.9.4 Bathroom

DRAIN STOPPER MISSING OR NON-FUNCTIONAL

Sink drain stopper is not present or not functioning properly. Recommend repair by a qualified handyman or plumber.

Contact a qualified plumbing contractor.

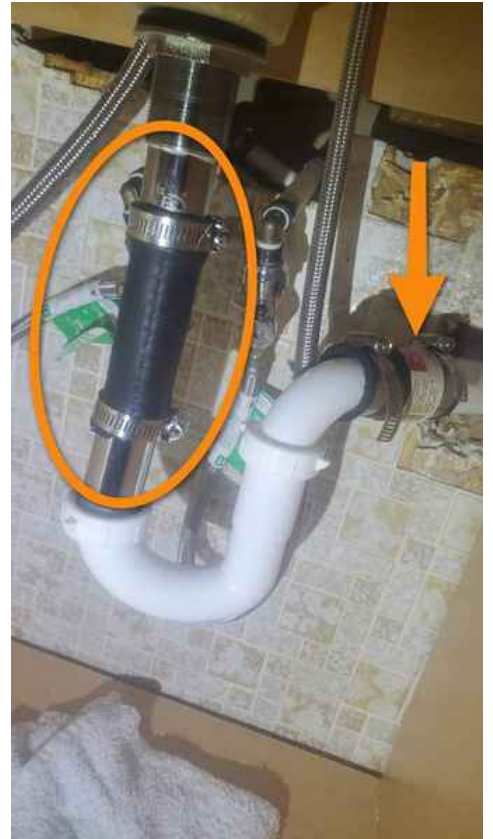
4.9.5 Bathroom

IMPROPER PLUMBING OBSERVED

An automotive type rubber hose was observed to be installed with automotive hose clamps (circled below). This is an improper installation and should be repaired by a qualified plumbing contractor or handyman.

Also, there was a "Fernco" coupler observed (arrow below). While these Fernco rubber couplers are not technically a defect, they are not considered best practice and should be replaced as they have a higher failure rate than traditional plumbing.

Contact a qualified plumbing contractor.

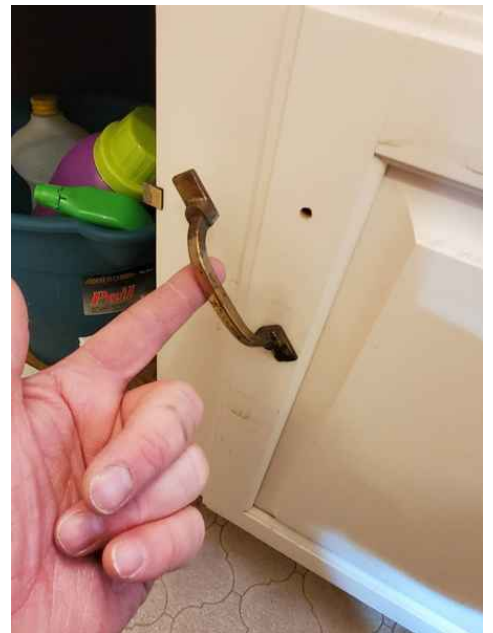
4.11.1 Countertops & Cabinets

CABINET HANDLE LOOSE

One or more cabinet handles or knobs were loose and/or not secured properly. Recommend repair by a qualified handyman.

Contact a qualified handyman.

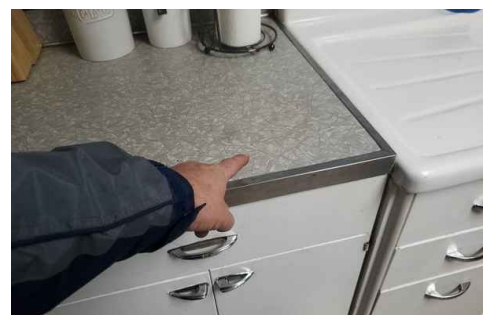
4.11.2 Countertops & Cabinets

Kitchen countertop observed to be inadequately secured. Recommend qualified handyman evaluate and secure countertop properly.

Contact a qualified handyman.

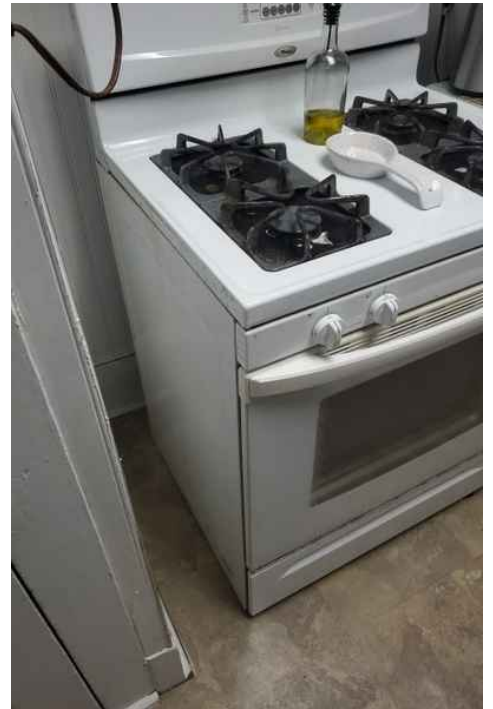
4.13.1 Range/Oven/Cooktop

Safety Hazards**ANTI TIP UNSATISFACTORY**

There was no anti tip-over device present on the range/oven. This is a safety hazard. Anti-tip brackets are metal devices designed to prevent freestanding ranges from tipping. They are normally attached to a rear leg of the range or screwed into the wall behind the range. Also called a range safety clip, these devices secure freestanding ranges to the floor or back wall, preventing them from tipping when the oven door is open and/or an oven rack with weight on it is pulled out.

It is recommended to have an anti-tip device installed by a qualified handyman.

Contact a qualified handyman.

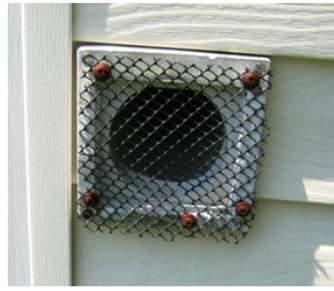
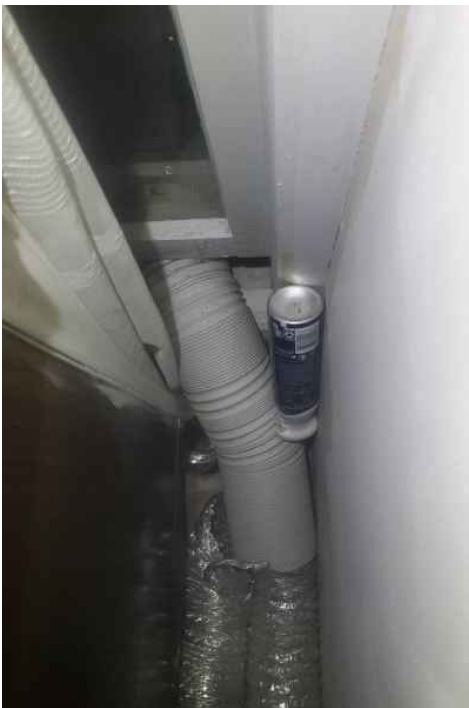
4.17.1 Clothes Dryer Details

The exhaust duct for the clothes dryer was observed to be improper or inadequate.

- Must be an approved material.
- Must be a single length — no connecting sections allowed.
- Can't be concealed within construction, such as passing through floors, walls, hidden spaces, etc., or be longer than 8 feet.
- Only flexible ductwork listed, labeled, and in compliance with UL 2158A can be used
- Should terminate outside the building at least 3 feet from any building opening, and at least 10 feet from an air conditioner or heat pump condenser
- The duct termination should be fitted with a closeable gravity or automatic damper (a backdraft damper).
- A screen may not be installed at the duct terminus, as it can trap debris and lint, which poses a fire hazard.

Recommend repair by a qualified handyman or HVAC contractor.

Contact a qualified handyman.

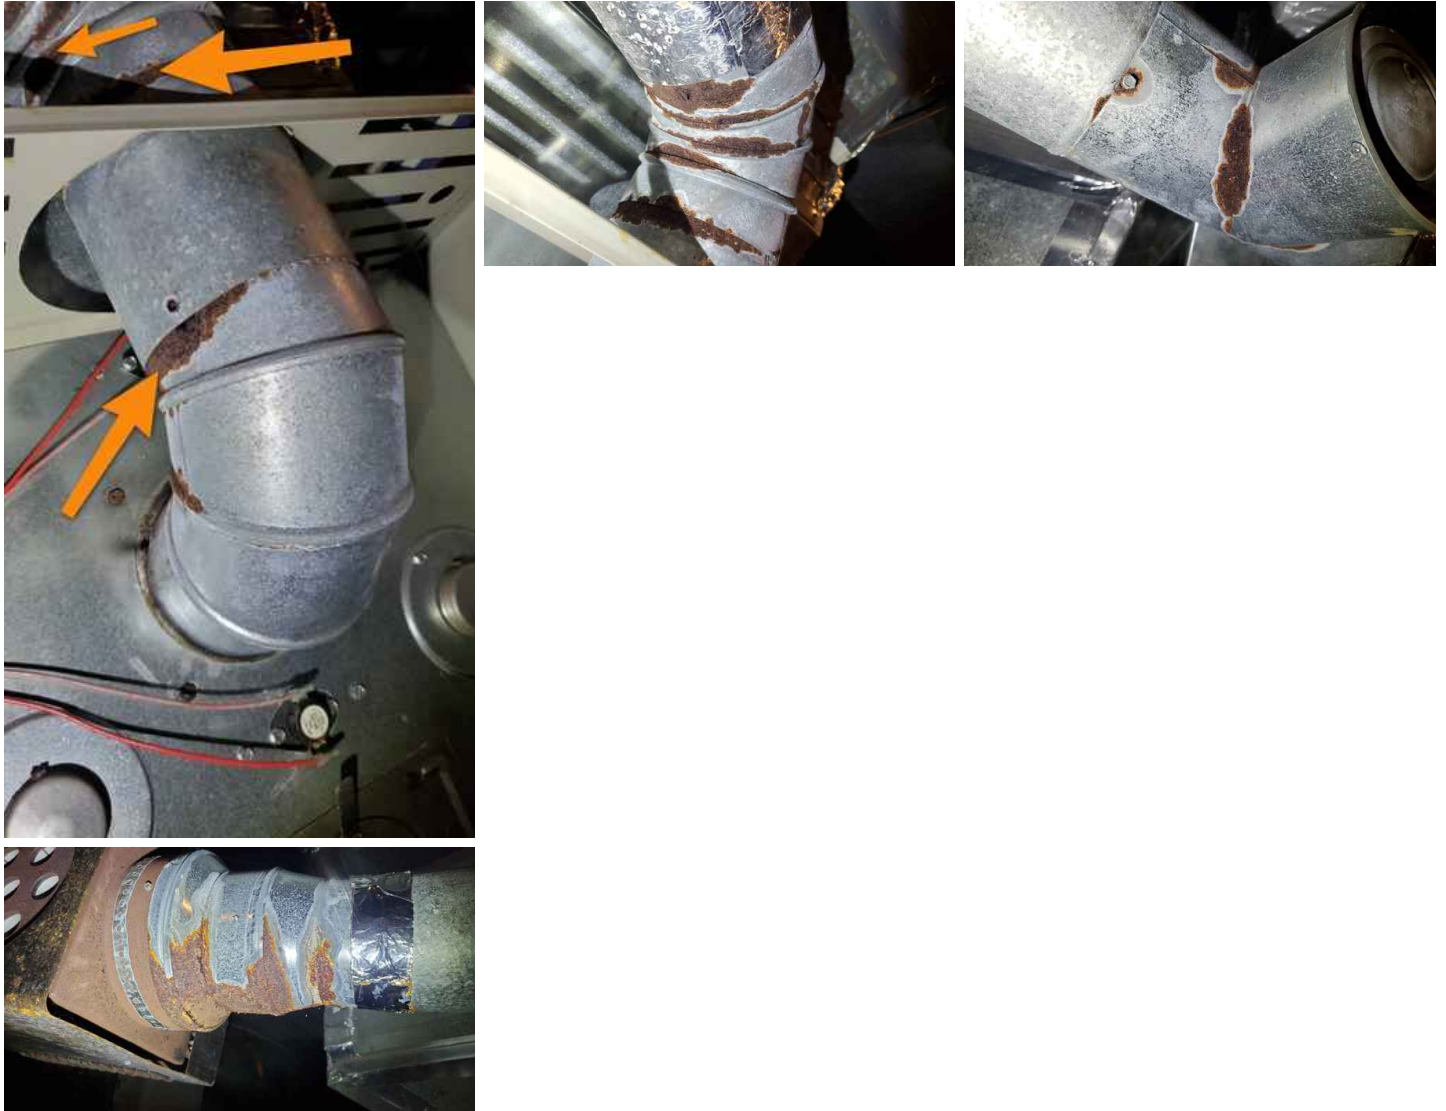
Rust and/or corrosion was observed in or on the furnace housing or other components of the appliance. This indicates moisture intrusion and can shorten the life of the unit, and possibly allow noxious gases such as carbon monoxide to enter the dwelling.

NOTE: Carbon monoxide is the byproduct of any gas combustible. Water heaters, gas furnaces, kerosene stoves, a gas range, all produce carbon monoxide.

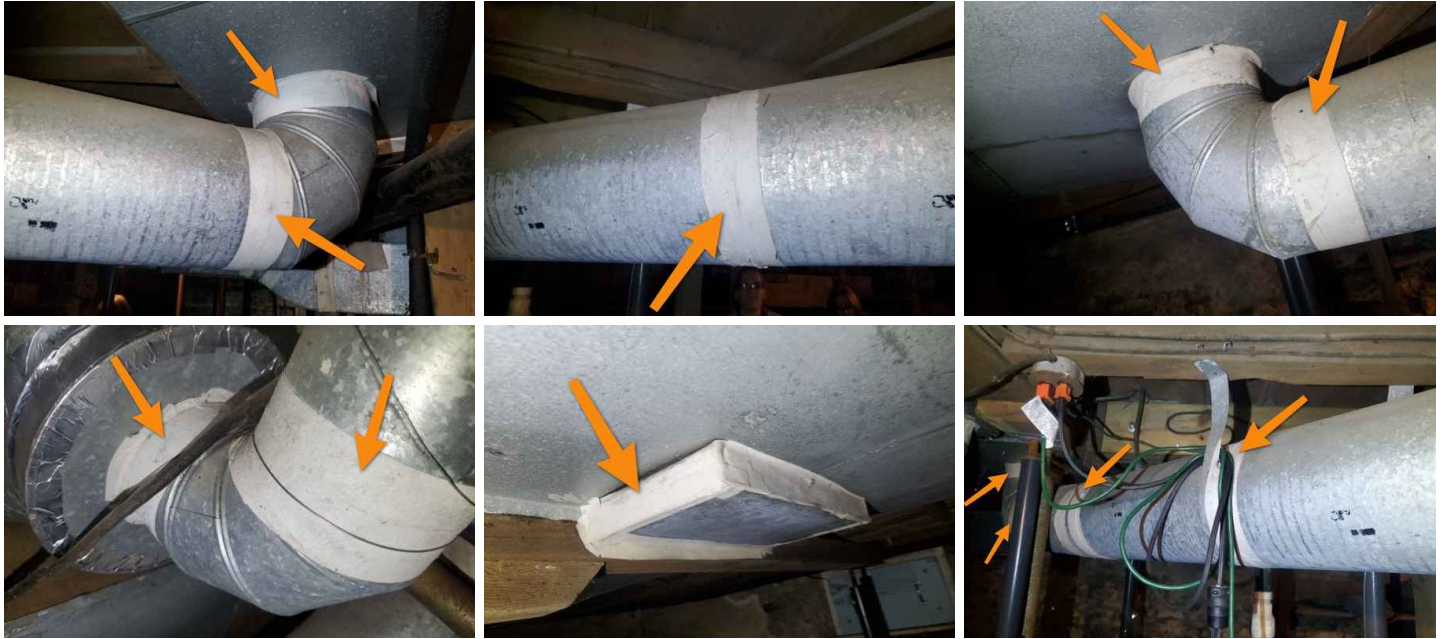
Furnace flu, ducts or vents were observed to have a white material that is possibly made from asbestos. Further evaluation and removal is recommended to be performed by a qualified asbestos remediation or environmental contractor.

Contact a qualified environmental contractor

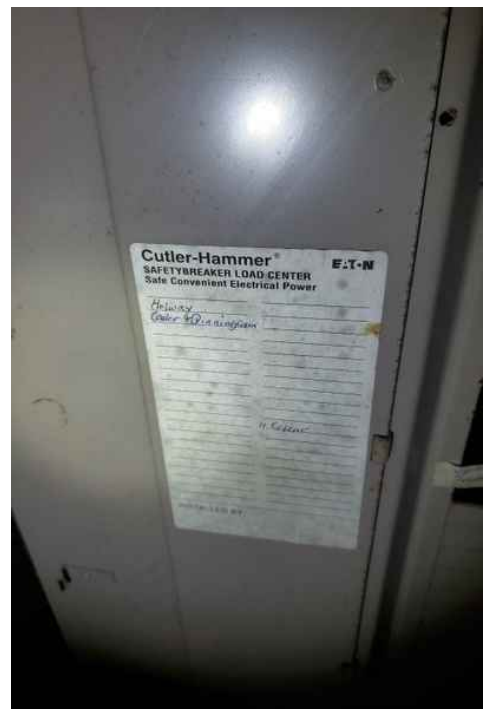
MISSING LABELS ON PANEL

At the time of inspection, panel was missing labeling. Recommend a qualified electrician or qualified person identify and map out breaker switch locations.

Contact a qualified electrical contractor.

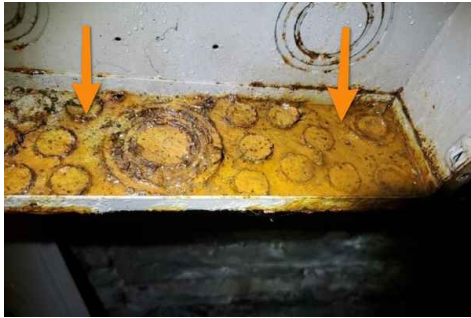
6.2.2 Main & Subpanels, Service & Grounding, Main Overcurrent Device

RUST AND/OR CORROSION OBSERVED

Main Panel was observed to have rust and/or corrosion. This is an indication of past or present moisture intrusion. It is recommended that the source of moisture be identified and remediated.

Recommend monitoring.

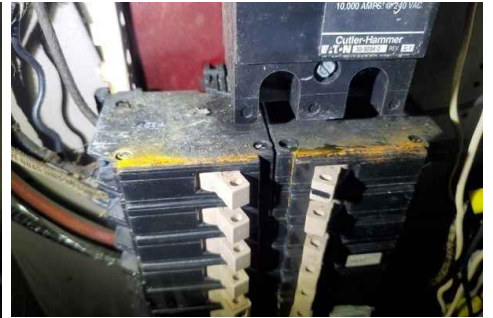
6.3.1 GFCI Protected Outlets

INADEQUATE GFCI PROTECTION

GFCI protection not present in all required locations. Recommend licensed electrician upgrade by installing ground fault receptacles in all required locations.

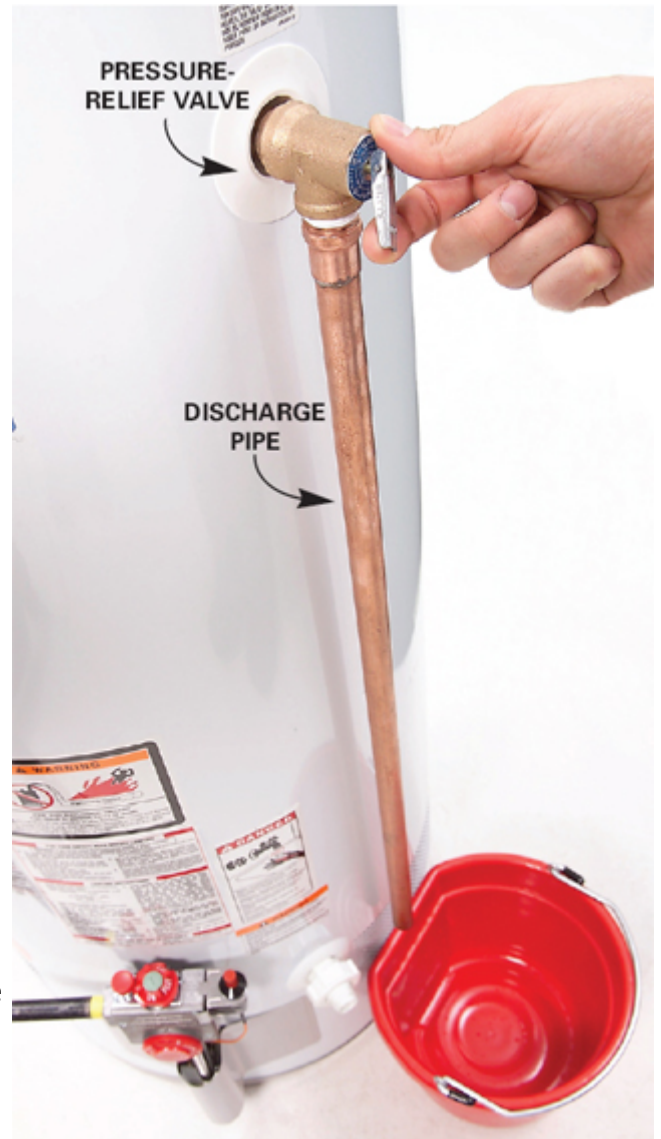
7.4.1 Hot Water Systems, Controls, Flues & Vents
IMPROPER TPR VALVE TERMINATION

12. be piped independently of other equipment drains, water heater pans, or relief valve discharge piping to the point of discharge.
13. not have valves anywhere.

14. not have tee fittings.
15. not have a threaded connection at the end of the pipe so as to avoid accidental capping.

Contact a qualified plumbing contractor.

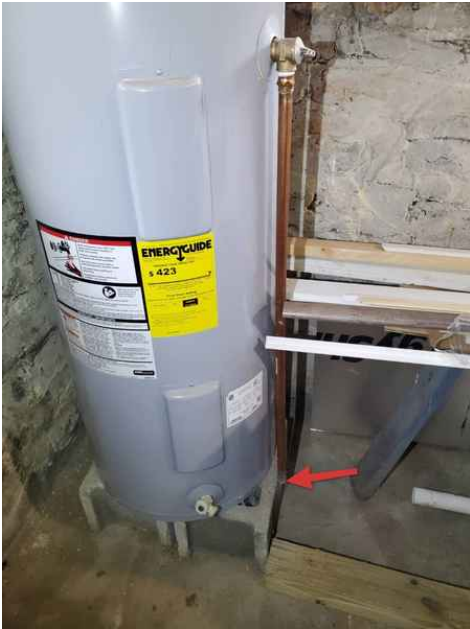
TPR Valve discharge pipe terminates 8 inches above the floor.

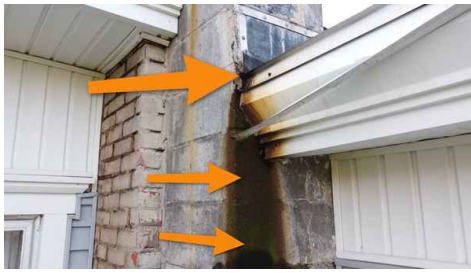
KICKOUT FLASHING - MISSING

Kickout flashing was not present in area(s) where it would normally be installed. This condition may allow moisture intrusion of the exterior wall covering or may direct water close to the foundation. Recommend repair by a qualified roofing contractor.

The installation of kickout flashing is recommended to be performed by a roofing contractor at any areas where gutters or fascia meet a sidewall, preventing rain water from infiltrating between the end of the gutter/fascia and the wall. Hidden damage may exist in areas where kickout flashing is missing and this should be investigated during the installation of kickout flashing.

Contact a qualified roofing professional.

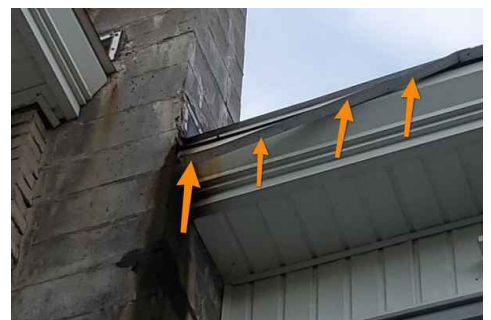
11.2.2 Roof Penetrations & Flashings

DRIP EDGE - DAMAGED

The drip edge flashing was damaged and/or displaced in areas. Repairs to the drip edge flashing as needed is recommended to be conducted by a roofing contractor.

Contact a qualified roofing professional.

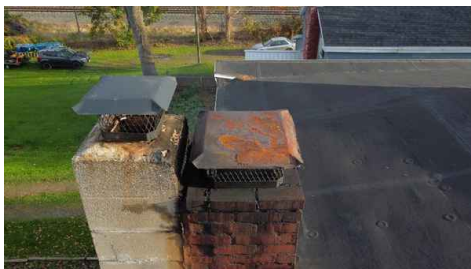
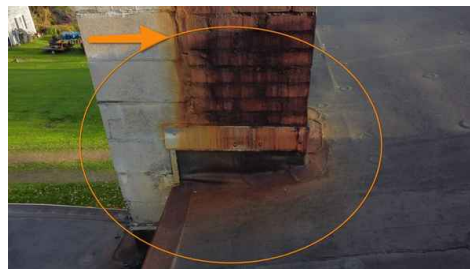
11.3.1 Chimney

CHIMNEY CAP - HEAVILY RUSTED

The chimney cap was rusted, had damage/deterioration present in areas, and had gaps present where different sections of this cap were joined together. All of these defects can allow for water infiltration to the underlying masonry, creating damage. An evaluation of the cap is recommended by a qualified chimney sweep with repairs or replacement made as needed.

Contact a qualified chimney contractor.

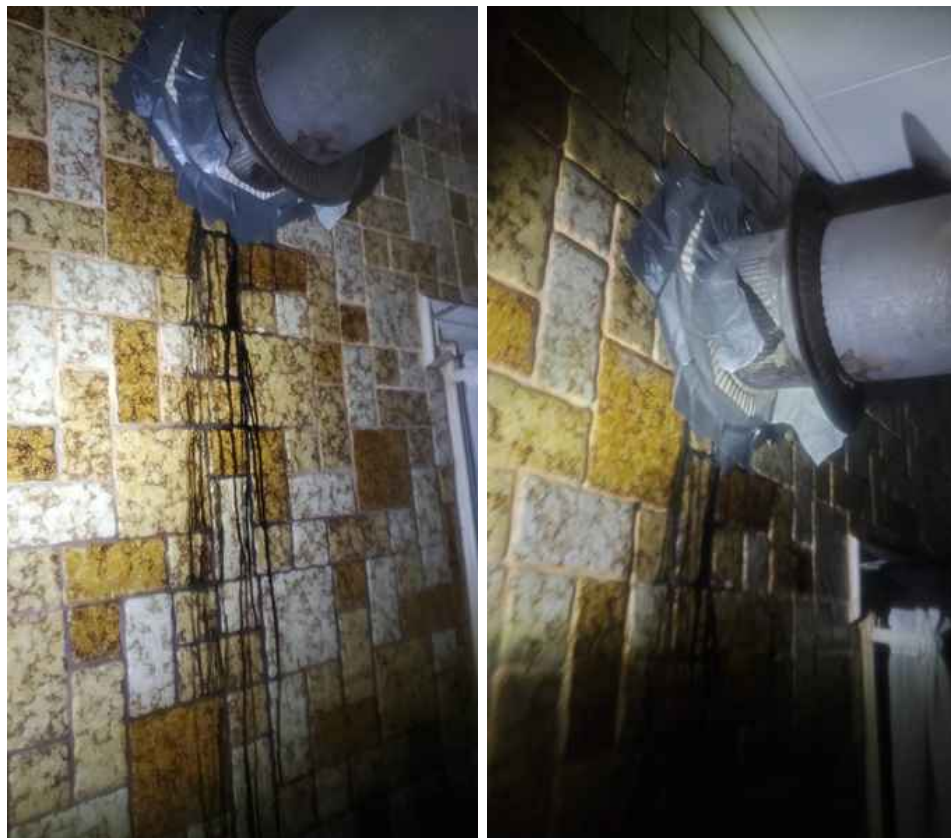
11.3.2 Chimney

CHIMNEY PIPE - CREOSOTE BUILD-UP

Creosote was observed on the spark arrestor/storm cap and visible portions of the flue liner, as well as dripping down the interior wall upstairs. This is a chimney fire hazard. Repairs to clean the chimney should be performed ASAP by a qualified chimney sweep.

Contact a qualified chimney sweep.

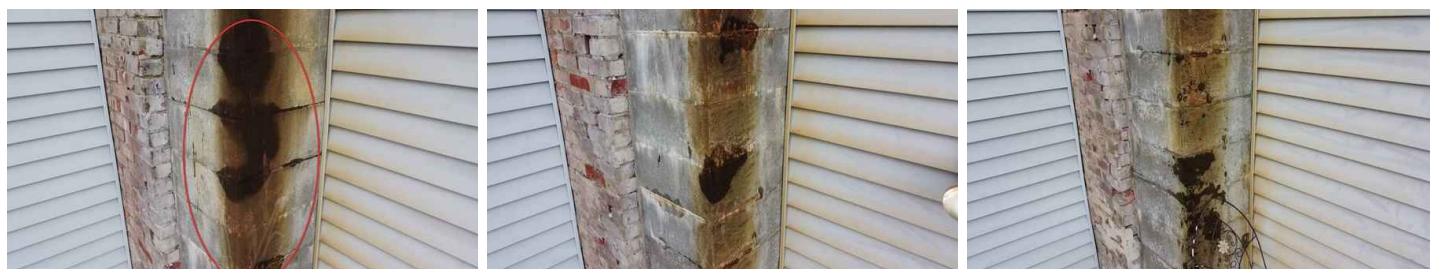
CHIMNEY - CREOSOTE AT MORTAR JOINTS

Contact a qualified masonry professional.

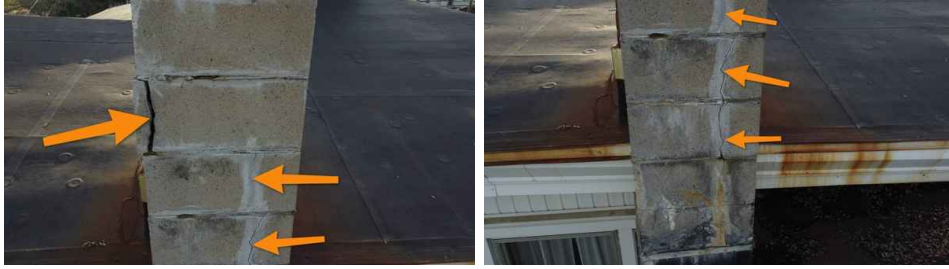
11.3.4 Chimney

MASONRY - CRACKING

Contact a qualified masonry professional.

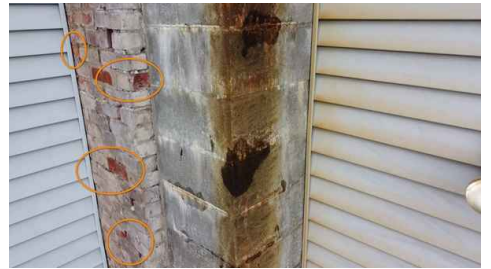
BRICK - SPALLING

Spalling of the brick face was present on areas of the chimney. This typically is associated with moisture infiltration into the masonry, as this moisture freezes and expands in winter months, damage to the brick occurs. Evaluation and repairs to the masonry as needed is recommended to be conducted by a qualified chimney mason.

Contact a qualified masonry professional.

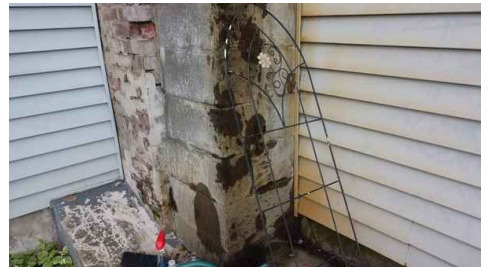
MORTAR - REPOINTING RECOMMENDED

Missing mortar was present between some bricks on the chimney. There were areas of deteriorated mortar in between bricks. Repairs to the mortar and chimney as needed is recommended to be conducted by a qualified chimney mason.

Contact a qualified masonry professional.

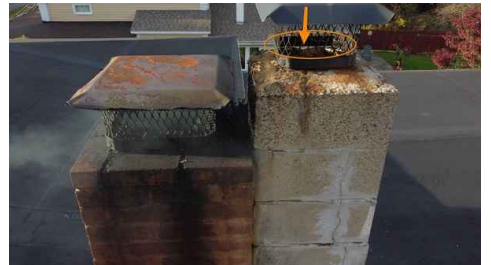
FLUE LINER(S) - DETERIORATION

Clay flue liner(s) were present that were deteriorated near the top under the storm cap. Evaluation of the liner(s) is recommended to be performed by a chimney sweep.

Contact a qualified chimney contractor.
